Arkema Facility - Harvey Response

Arkema Inc.

September 7, 2017

Project #109489 Summary

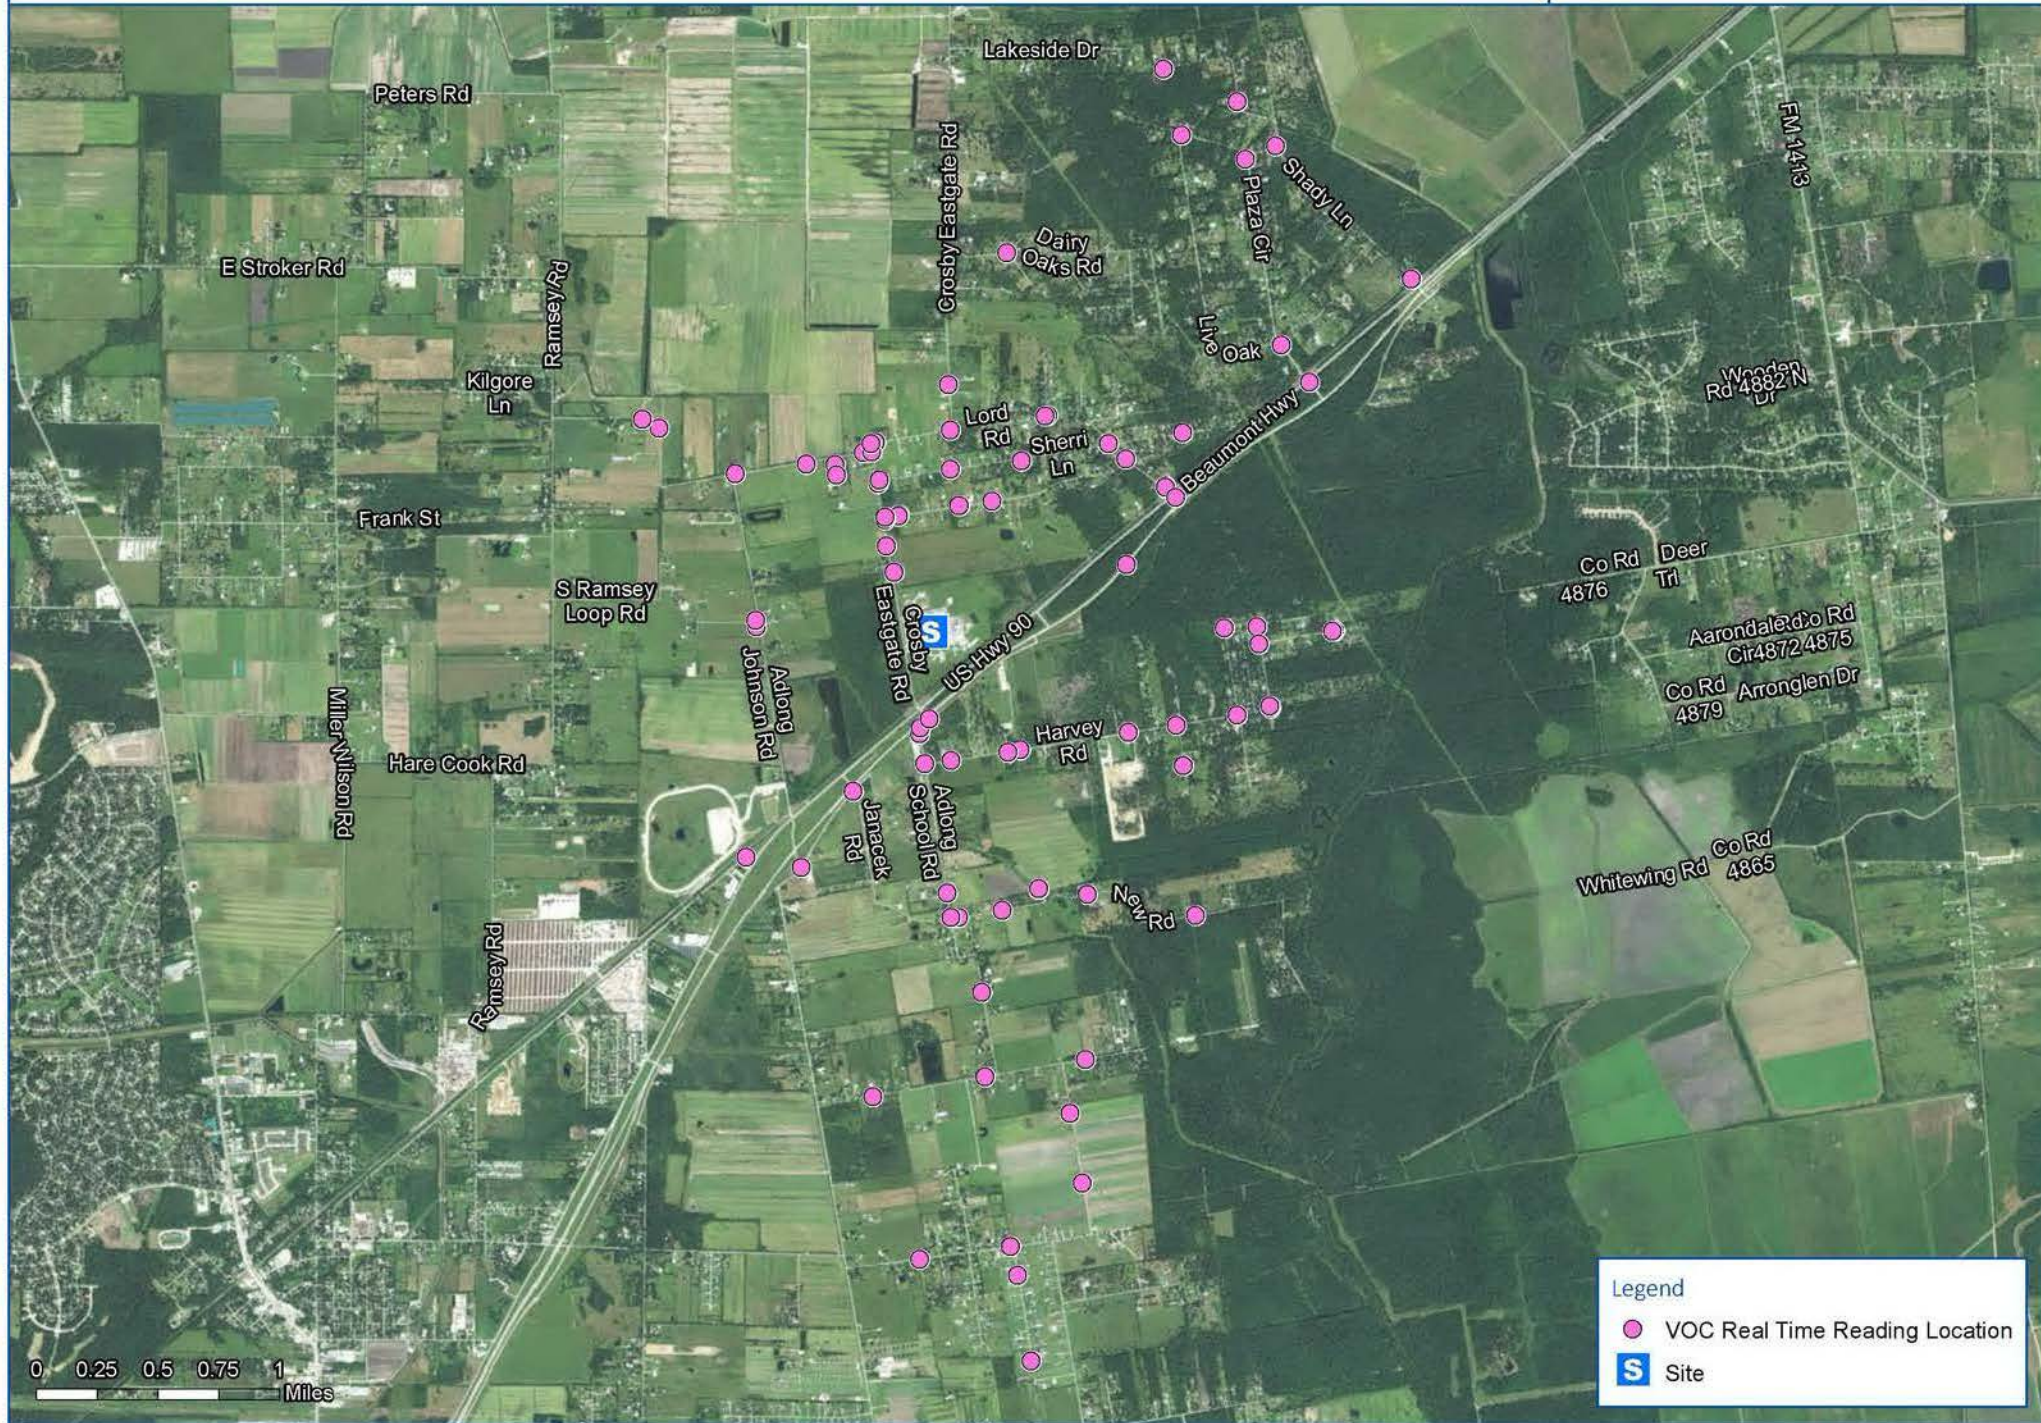
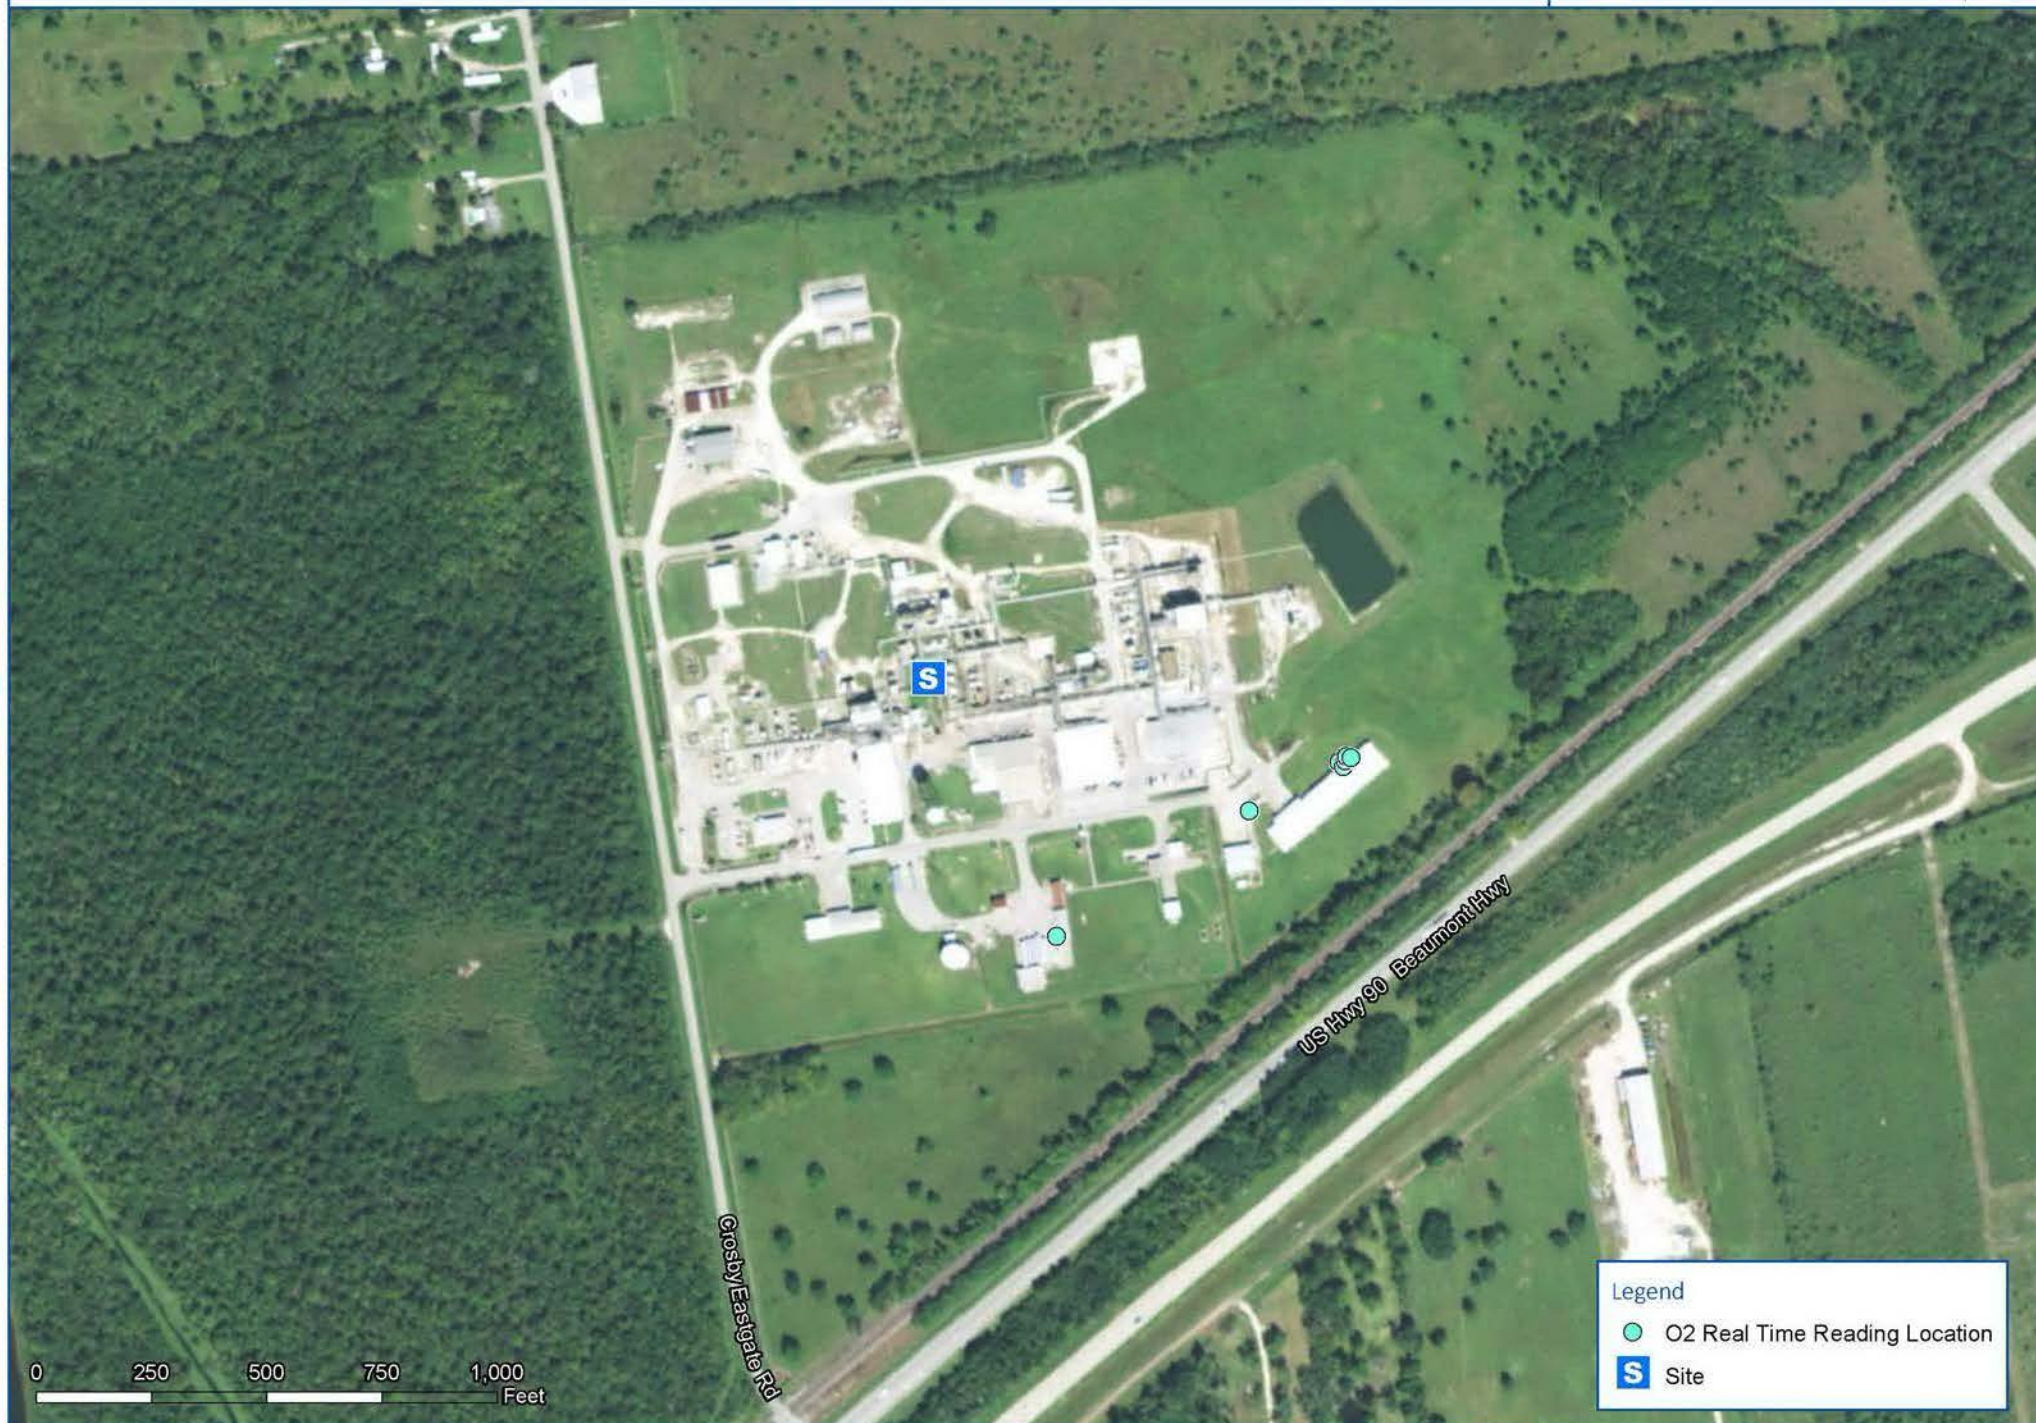
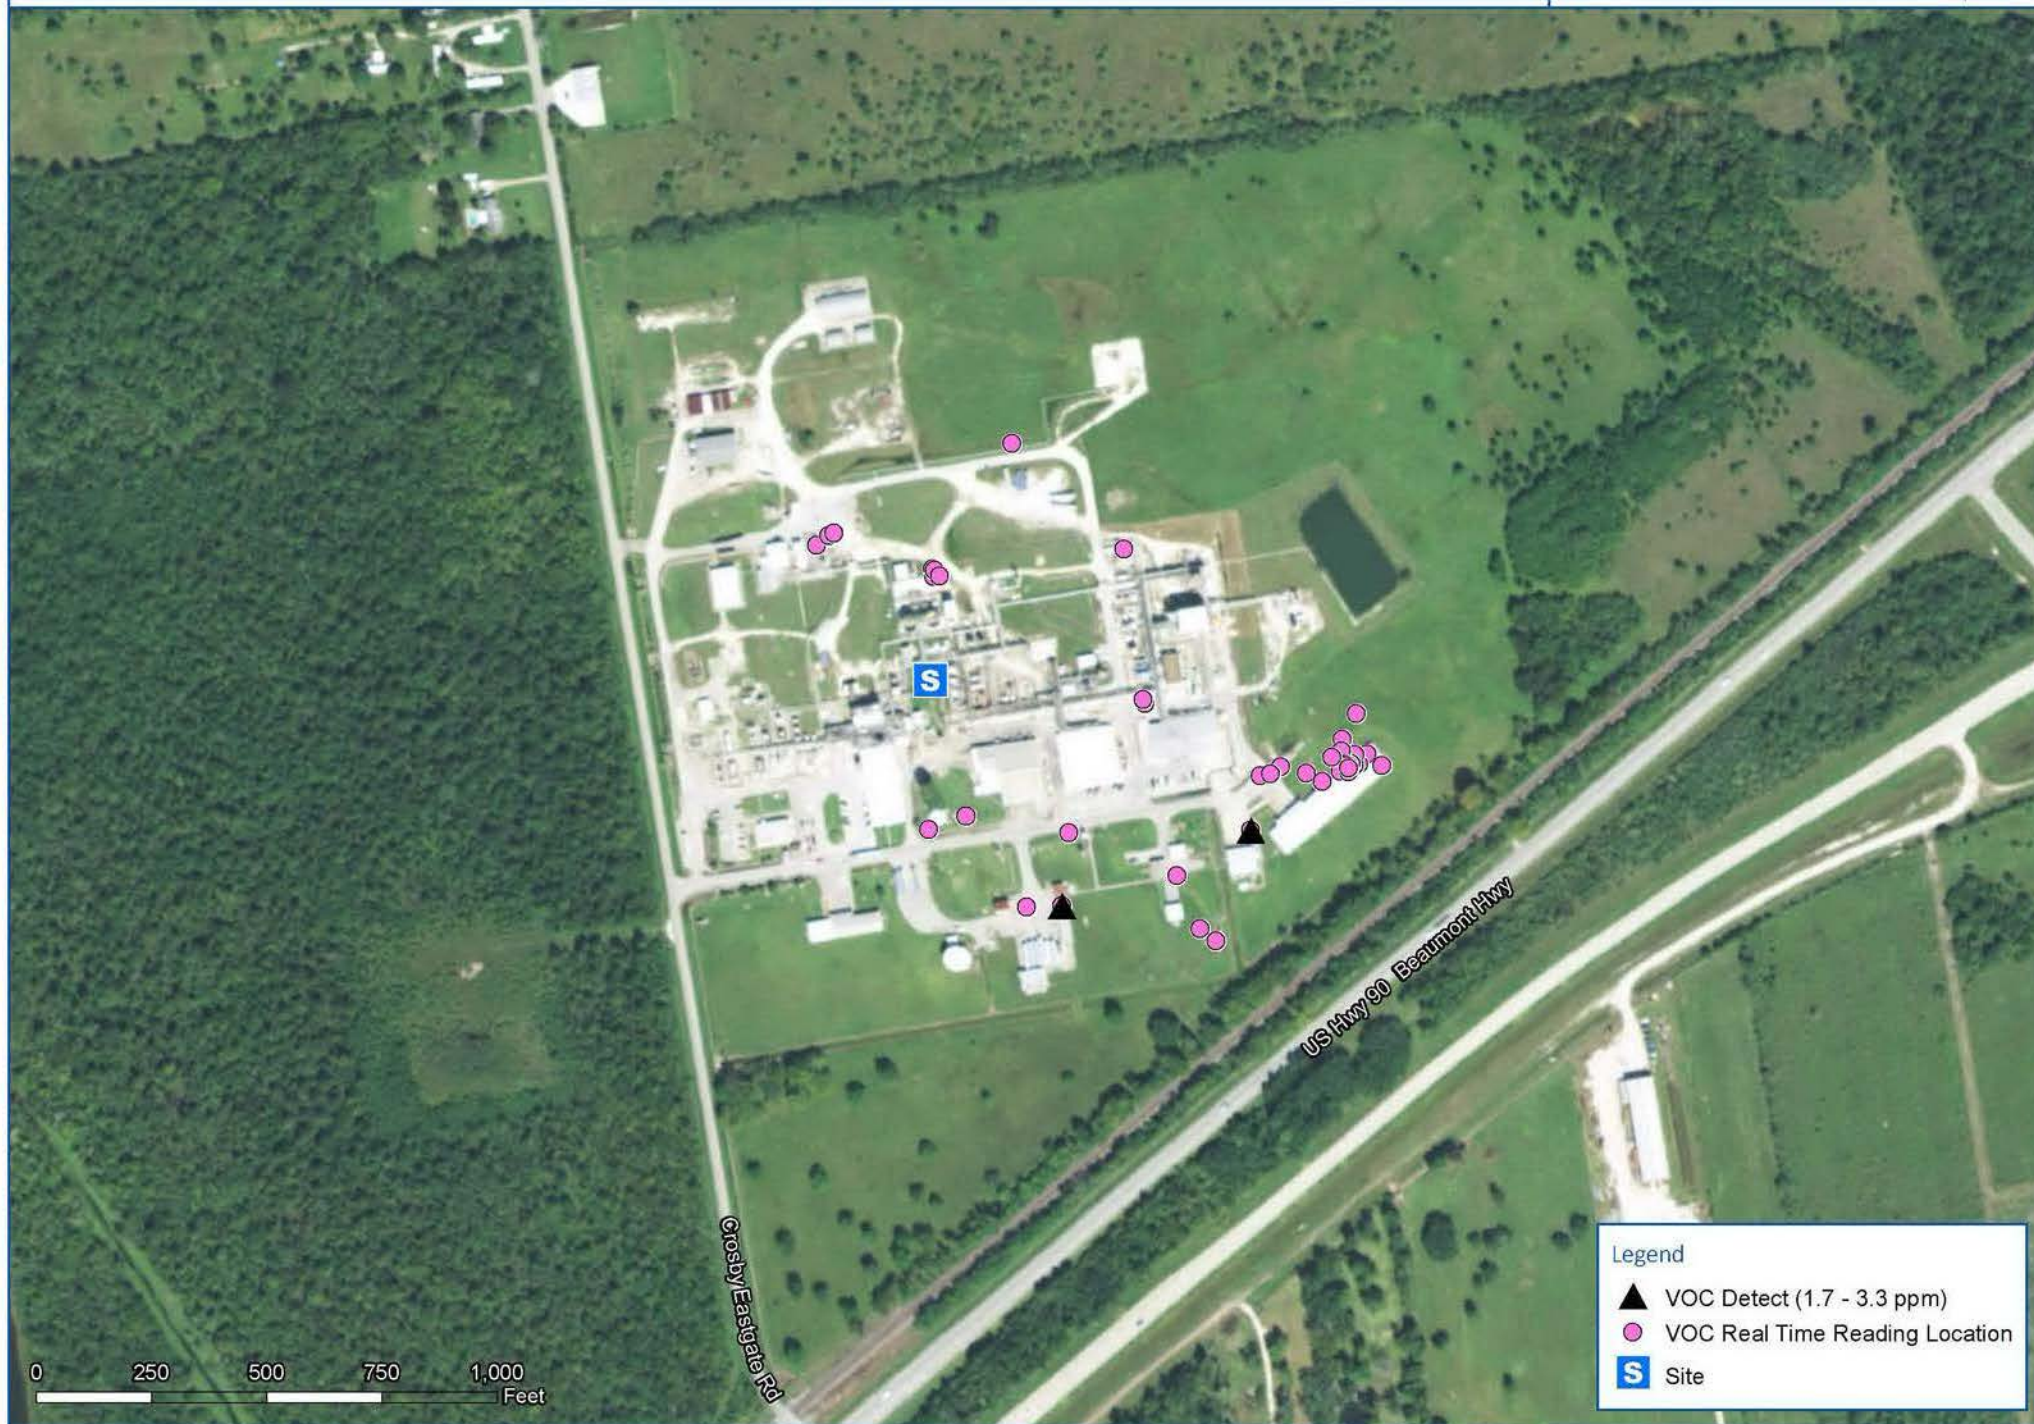
Handheld Real-time Air Monitoring Locations

Community VOC Hand-held Real-time Reading Locations

Harvey Response - 06:00 September 6, 2017 to 06:00 September 7, 2017

All real-time air monitoring instrumentation was calibrated per the manufacturer's recommendations prior to air monitoring. Handheld, real-time air monitoring was conducted for oxygen (O₂) and volatile organic compounds (VOCs) using RAE Systems MultiRAE instruments. Additionally, particulate matter (PM_{2.5}) was assessed using TSI SidePak AM510s. **Table 1** summarizes the data for all real-time air monitoring readings recorded in the Crosby, TX Community from 06:00 on September 6, 2017 through 06:00 on September 7, 2017 and Table 2 summarizes the Worker Activity real-time air monitoring readings from within the site boundary for the same period. Maps of real-time air monitoring locations are provided as **Attachment B**.
